NASA TN D-4879

# RADIOFREQUENCY TRANSMISSION CHARACTERISTICS OF SEVERAL ABLATION MATERIALS

*by Melvin C. Gilreath, William F. Croswell,  
and Stark L. Castellow, Jr.*

*Langley Research Center  
Langley Station, Hampton, Va.*

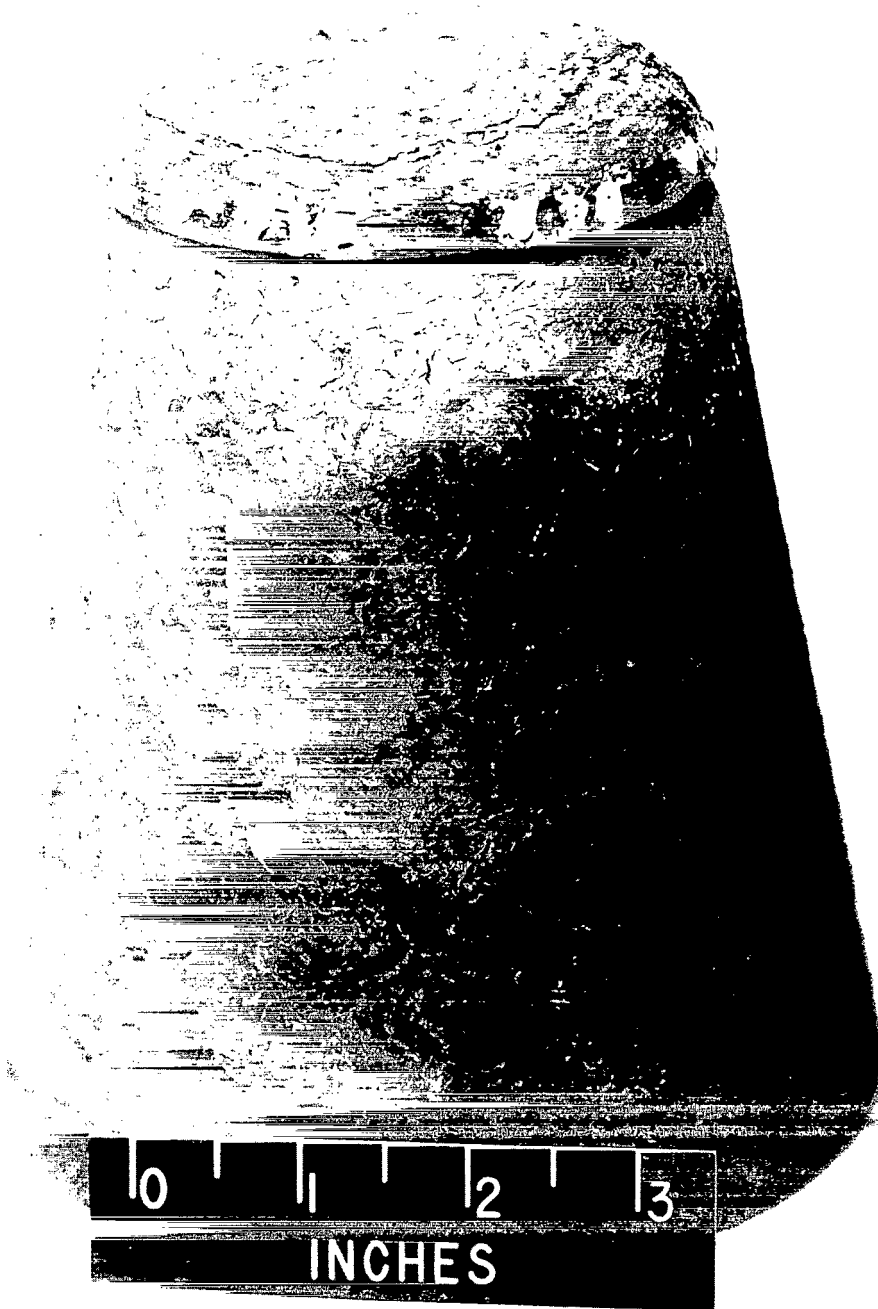
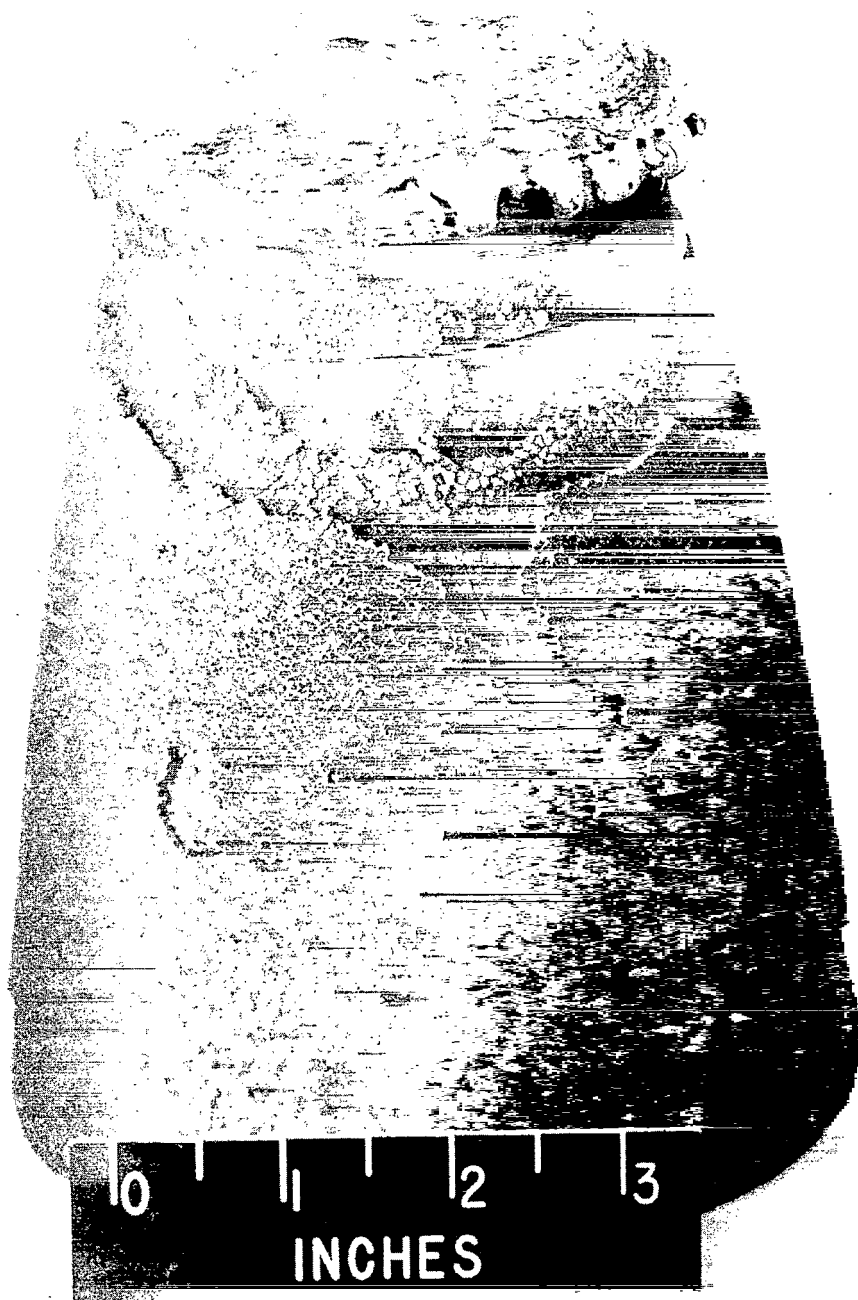
(d) NASA E4A1.

(e) Narmco 4032-C.

(f) Phenolic nylon.

(g) Narmco 4028.

that which remained had the appearance of a wood char. The Avcoat 5026-39 model is shown in figure 10(c). A deposit of glass was left on the upper portion of the model, apparently from the erosion of the phenolic-asbestos nose cap. The test material appeared to be charred to the bond line. Figure 10(d) shows the E4A1 test model, on which a low-density phenolic-nylon nose cap was used. Immediately after the thermal test began, large cracks developed in the test material; however, as the test continued the cracks appeared to close up somewhat until they reached the condition shown in the photograph at the end of the test. Some of these cracks occurred over the test antennas. In addition, this model had to be handled with extreme care to permit measurement of the antenna characteristics after the thermal test because the material appeared to be separating from the substructure at the bond line and was very fragile. Figure 10(e) shows the Narmco 4032C material which developed many small surface cracks during the thermal test. The phenolic-nylon model (fig. 10(f)) shows the type of carbonaceous char layer formed during the ablation of this type of material. The material appeared to be charred completely to the bond line and the nose cap was fused to the substructure and had to be sawed off to allow removal of the test antennas. A considerable amount of material had fallen off the model, making measurement of the antenna characteristics difficult. Figure 10(g) shows the Narmco 4028 material, which, like the Narmco 4032C material, developed many small surface cracks during the thermal test.
